Mr		
Attorney		
	& A	
		_, Suite
	, TX	
Re:	Style:	
	•	In the Judicial District Court of Harris County, Texas.
	Claim #:	·
	Subject:	Preliminary report.
	File No.:	Ours Yours
Dear Mr.	•	_;
0 51	10.200	
		25, at 7:36 p.m., after sunset, a collision occurred in the block of Highway
approxin	nately 500 fe	eet south-east of the intersection with Drive. The collision involved a 2000 Honda
Civic dri	ven by Mr.	Z and a 2000 International tractor-1992 Trailmaster trailer driven
by Mr		K Mr. Z died as a result of the collision.

This report presents a distillation of data related to an auto/tractor-trailer collision that took place on February ___, 200_, at 7:36 p.m., about an hour and twenty minutes after sunset, in the_____ block of Highway ___ in Harris County, Houston, Texas.

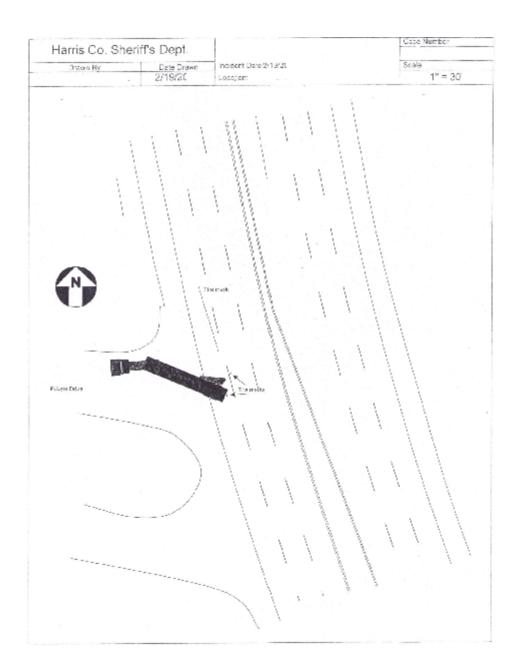
Visibility in the area at the time was ten miles.
Figure 1, next page, is a schematic drawing of the accident scene from the Detail Report for Harris
County Law Enforcement.

Figure 1 Schematic drawing of the accident scene.

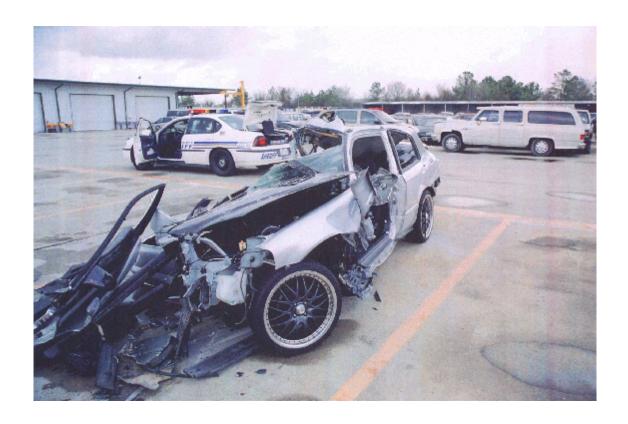
The police weight data show this vehicle to weigh, post accident, 1,650 pounds. These vehicles typically have a curb weight of up to 2,500 pounds.

Photograph 1 is a photo of the Honda Civic accident vehicle taken by the police.

Photograph 1. 2000 Honda Civic Coupe

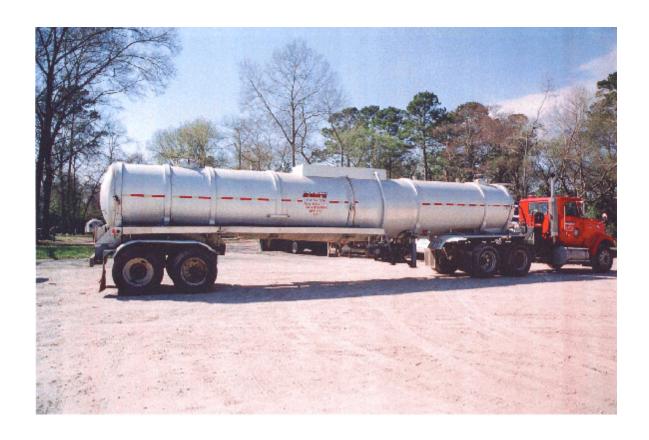
Weight data on this unit provided to Deputy ______ by the _____ Company indicate the tractor to weigh 17,160 pounds and the trailer to weigh 14,100 pounds, empty.

Photograph 2 is of the 2000 International tractor and 1992 Trailmaster trailer accident vehicle.

Photograph 2.
2000 International tractor and 1992 Trailmaster trailer

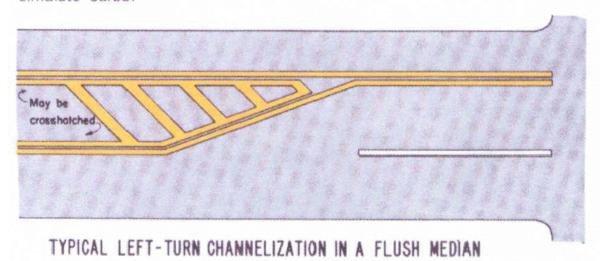
TX 3B-14 (Rev. 1/83)

3B-10.1 Left-Turn Channelization Markings

Pavement markings for left-turn channelization may be accomplished by the use of paint, thermoplastic, traffic buttons or jiggle bar tiles. The choice of material will usually depend upon several conditions such as location, traffic volumes, maintenance and degree of crossing restriction desired.

When the channelization is intended to be non-restrictive and turns are permitted across it into or out of driveways, the pavement markings should be paint, thermoplastic or traffic buttons. When the channelization is intended to be restrictive and turns are discouraged or prohibited across it into or out of driveways, the pavement markings should be jiggle bar tiles. Channelization is formed by two double yellow lines when paint, thermoplastic or traffic buttons are used; however, when jiggle bar tiles are used, only single lines of tiles are required, since jiggle bar tiles simulate curbs.

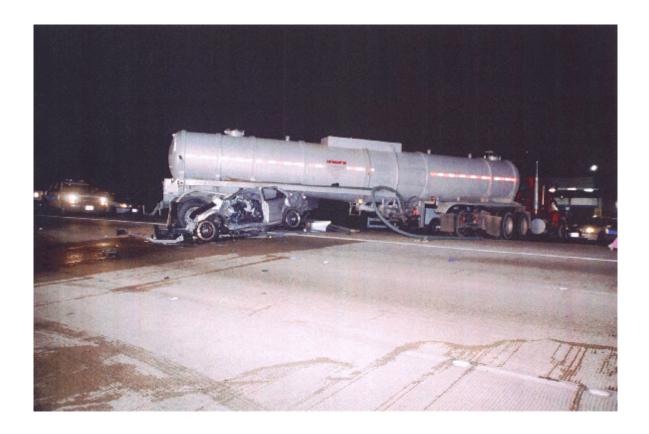
Photograph 3 shows the accident vehicles in their final rest positions after the collision. Red and white conspicuity tape is visible along the length of the side of the trailer.

The tractor-trailer truck with the Honda coupe against the trailer tandems.

9.	A driver judges the distance of an oncoming vehicle at night by the separation of the headlights and the speed of the vehicle by the rate of spread of the separation of the headlights as the vehicle approaches.
	In the night, a vehicle's headlights far away provide distance information first and speed information second. Speed information develops as the vehicle approaches and the headlights appear to spread. The faster the lights spread, the faster the vehicle is moving.
	The truck had its headlights and marker lights on and a long length of highly reflective conspicuity tape along the length of the side of the trailer. The conspicuity tape can be seen in photograph 3, page 16.
	The highway in this area is not lighted. There was a nearly full moon (83%) above with clouds in the sky. The moon was two hours short of being directly overhead.
	The front of Mr. K's tractor was across the roadway and entering the driveway of the gas station when he saw "two sets of lights coming at me at a high rate of speed at that point." The rear of the trailer was in the middle lane or the outside lane when struck by the Honda. See Figure 1, page 6 and accident photograph 3, page 16 for the location of the two vehicles at rest.

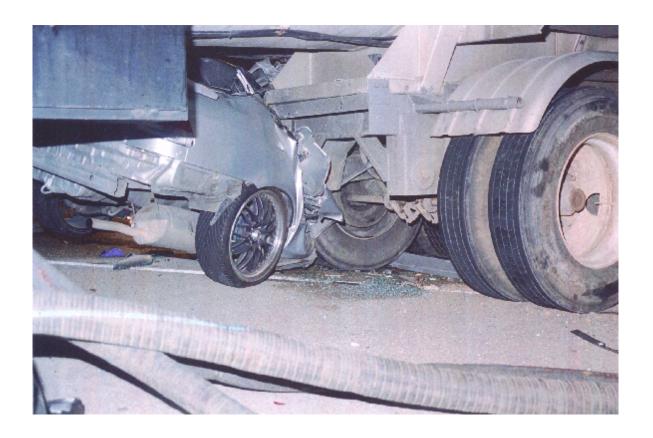
Photograph 4 is of the Honda coupe in its final rest position, wedged against the trailer's tandem wheels and under the trailer tank.

The right side sheet metal of the Honda is torn and wrapped forward of the trailer's dual tires. This shows that the Honda impacted the truck at a high rate of speed and penetrated the area of the truck. The truck did not impact and penetrate the Honda.

Honda coupe against trailer tandems and under the tank trailer.
